**ACR(M)001: 2000 Test
for fragility on 6 metre
long panels of 25 mm
thick Safelock roof light
specimens from
Naturalight Systems Ltd**

Prepared for: Mr. Chris Paine
Sales Director; Naturalight
Systems Ltd

Test report number 224 357b

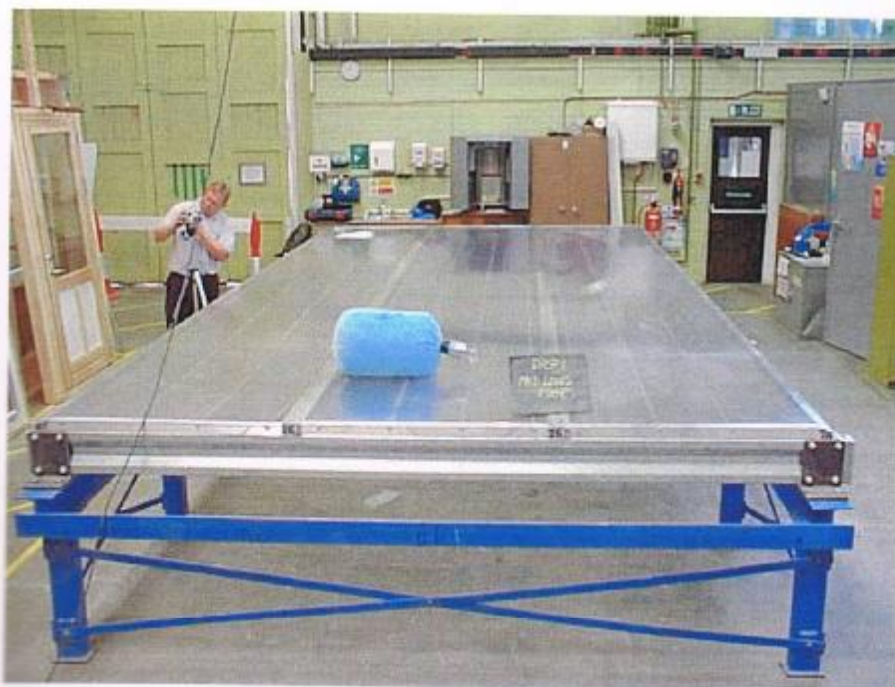
Figure 2. After the first drop at a point centre span between purlins close to a long edge of the panel

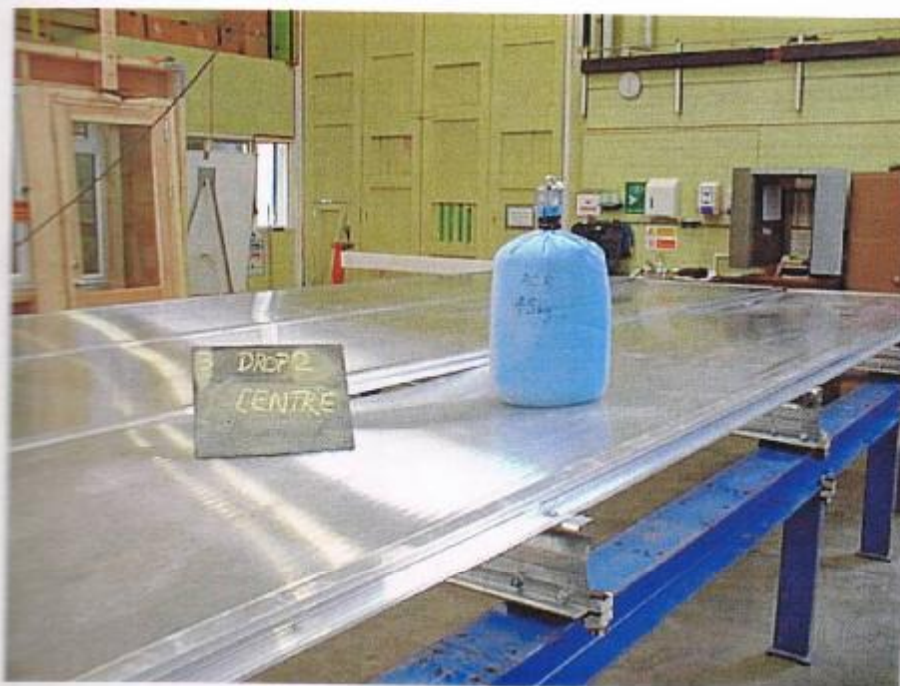
Figure 3. After the third repeat test to the centre of a roof light panel between purlins

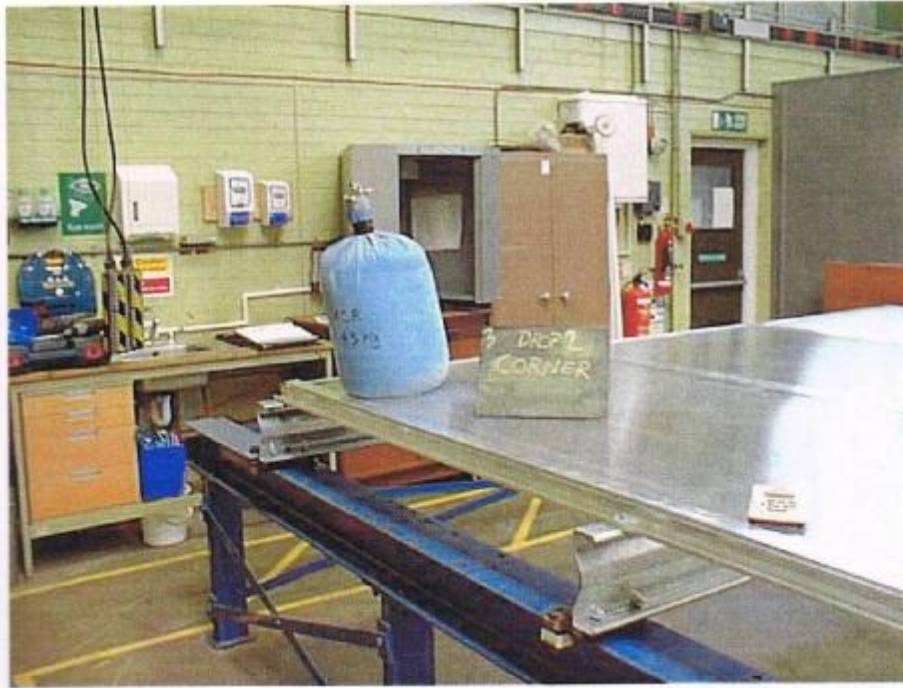
Figure 4. Third repeat test to a corner of a roof light panel

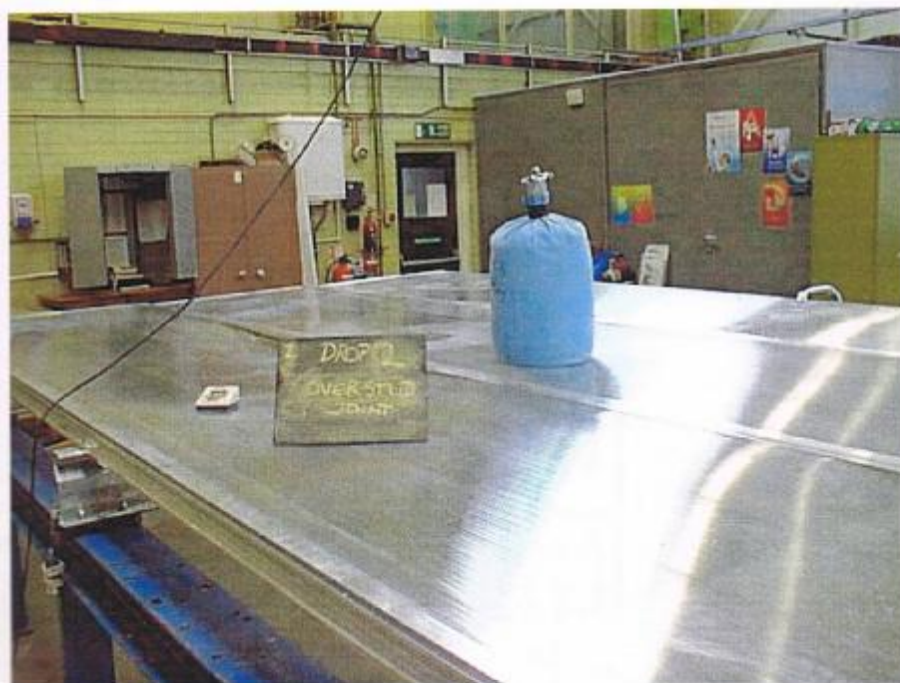
Figure 6. At a point over a joint in the threaded bar within the panels.
