**Interim report on
ACR(M)001: 2000 Test
for fragility on 25 mm
thick Fastlock roof light
specimens from
Naturalight Systems Ltd**

23 June 2005

Test report number 223 837

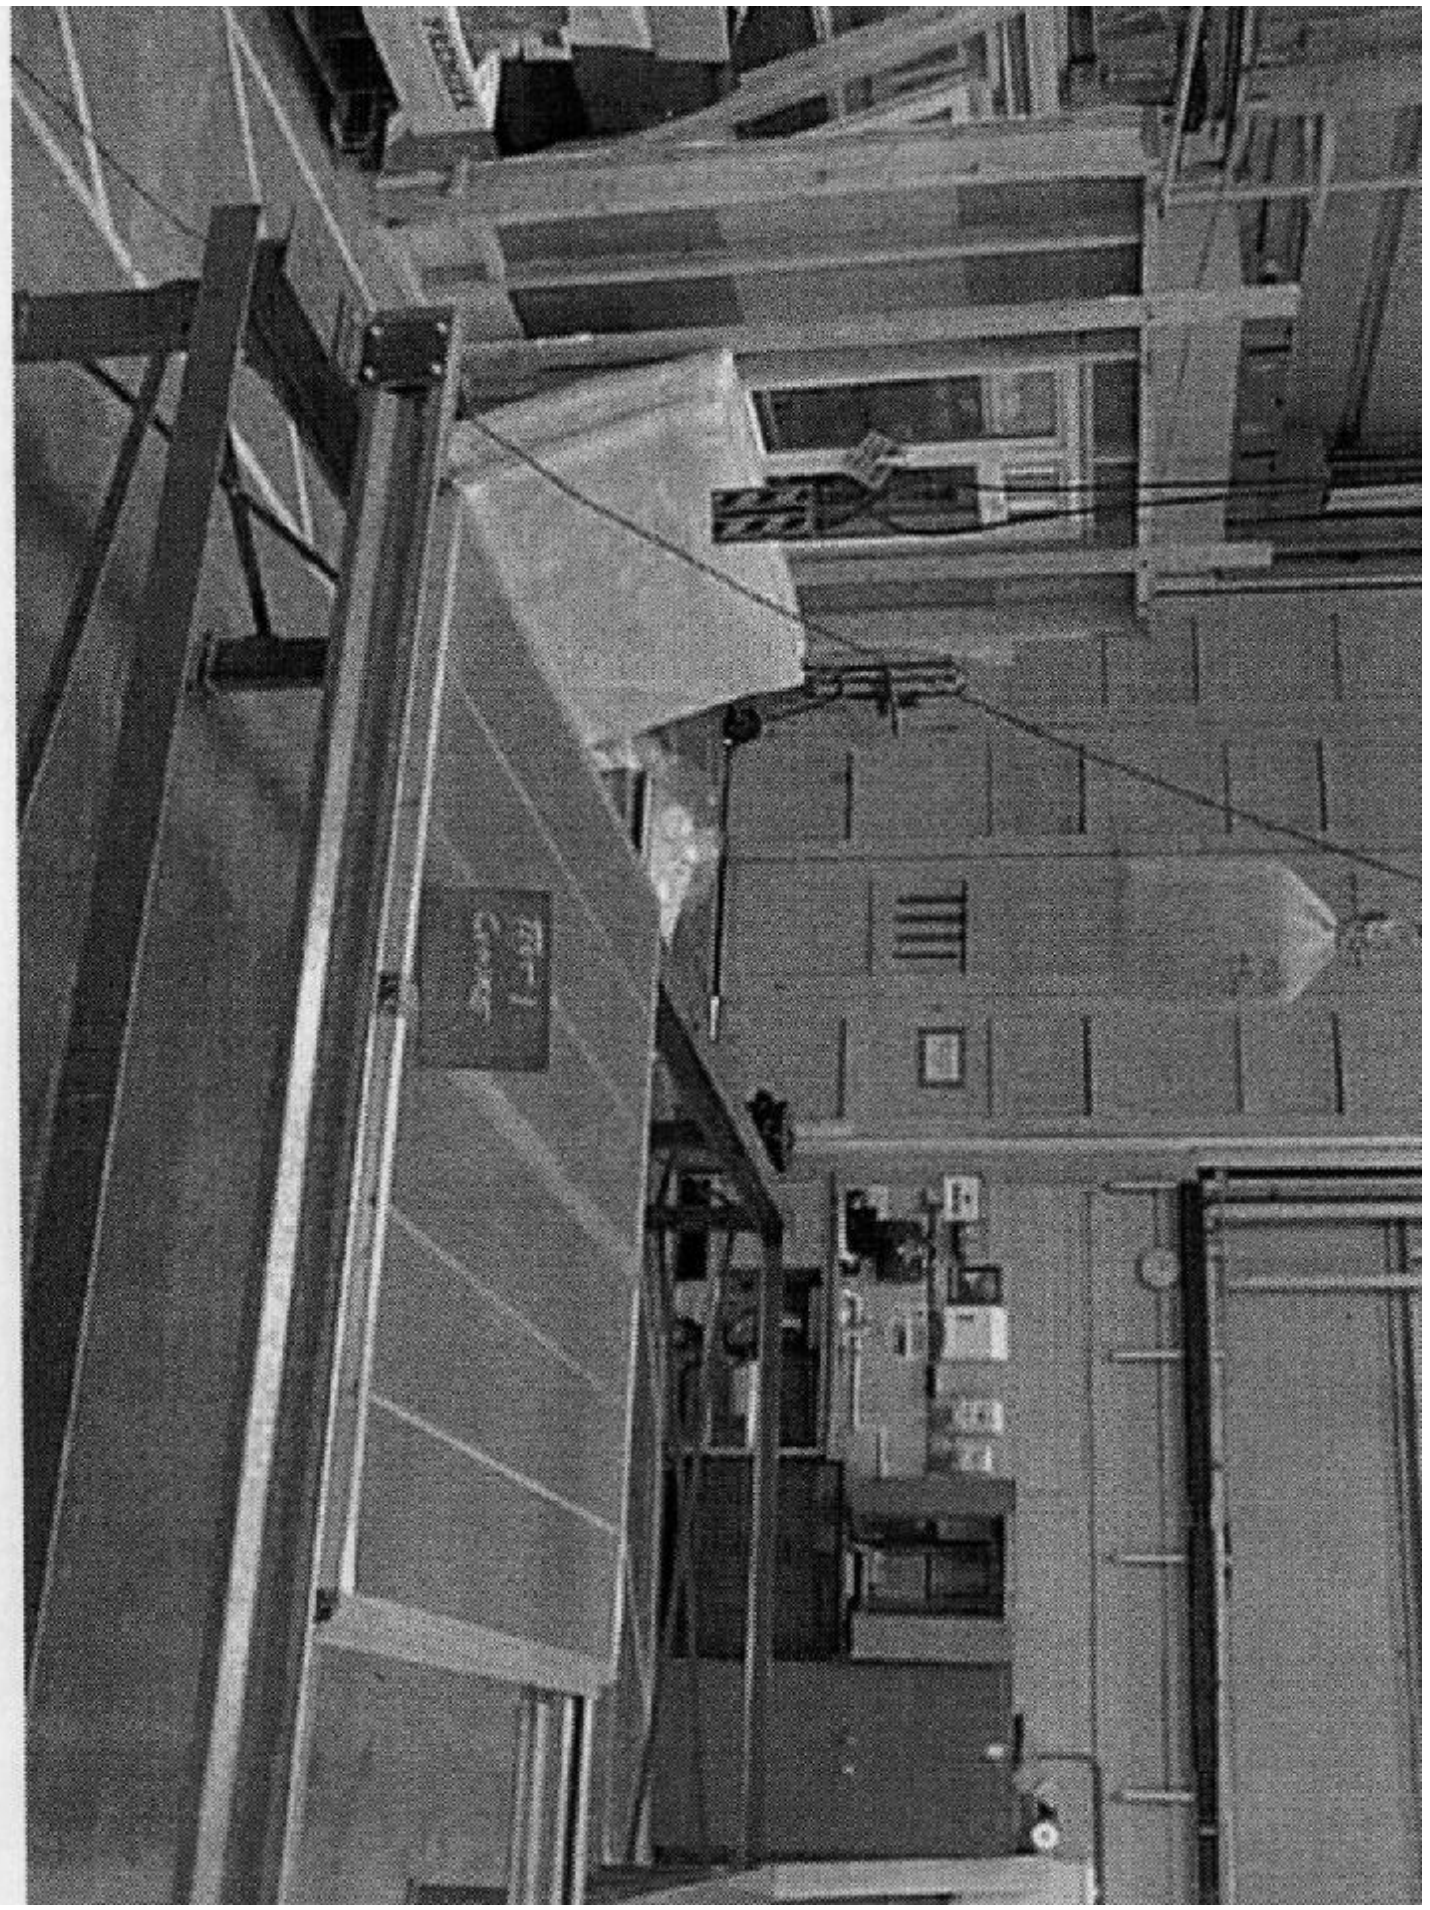
Figure 1. Sketch of the general layout of the roof light test specimen showing impact positions

Naturalight Systems Ltd supplied the new roof lights and components and assembled and fixed the test specimens onto the test rig at BRE. Figures 1 and 2 show the general test set up of the roof light test specimen mounted on BRE's ACR test rig.

The roof light test specimens were mounted horizontally on the test rig. In practice installation would be with an inclination of at least 10 degrees above horizontal. The purlins are fixed to cleats that in turn fix onto the test rig frame and the specimen is fixed to the purlins as described in Section 4 of this report and shown in Figure 1.
